**LASER DAMAGE THRESHOLD SPECIFICATION SHEET  
AND CERTIFICATE OF COMPLIANCE**

CUSTOMER: Perkins Precision Developments, LLC

TEST LOG NUMBER: 58723

PART ID: P18-43

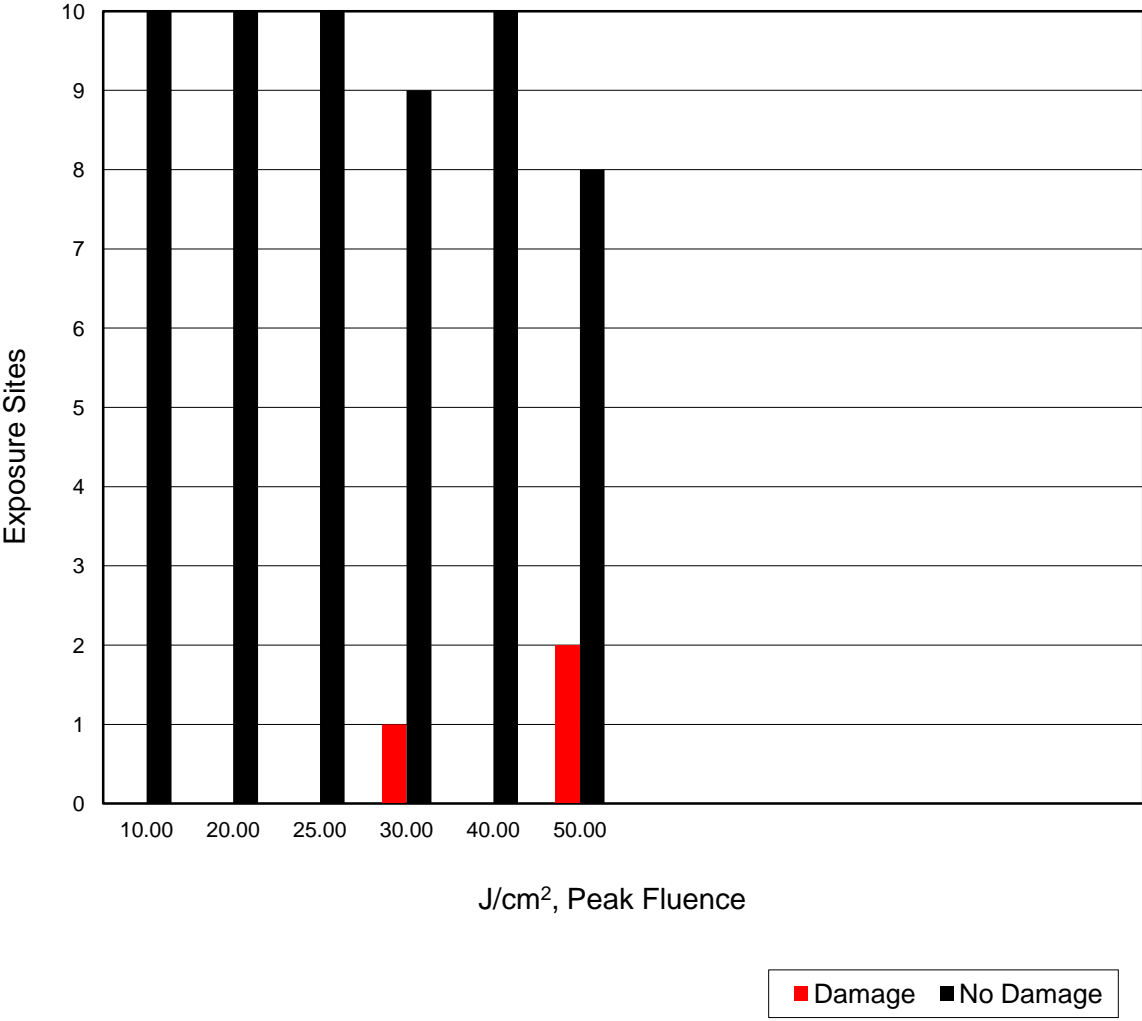
## Exposure Histogram 58723

Test Number	58723
Run Number	P18-43
Threshold	25.00 J/cm <sup>2</sup>

fluence	Out of	Damage	No Damage
10.00	10	0	10
20.00	10	0	10
25.00	10	0	10
30.00	10	1	9
40.00	10	0	10
50.00	10	2	8
